# Salford, Greater Manchester

Project description	Whole house retrofit of mid-terrace house, built c.1900.																		
Treated Floor Area	70 m <sup>2</sup>																		
Dates of work	2008 – 2010																		
Project team	Myself, along with various sub-contractors for different tasks																		
Introduction	House was damp and dark when I bought it, and parts of the house (e.g. the bathroom) were freezing in cold weather. I had to do a certain amount of things anyway since the house was in a fairly bad state (e.g. window frames were rotten), so I found that this was a good time to try to make it better while I was at it. I didn't know much about energy efficiency or in what order to do things, so I spent some cash on a few books and read up about what I should do, after which I made a do-list and decided roughly in what order things should be done.																		
Space heating demand & carbon emissions – before and after according to PHPP	<div style="display: flex; justify-content: space-around;"> <div style="width: 45%;"> <p><b>Before:</b></p> <p><b>After:</b></p> </div> <div style="width: 45%;">

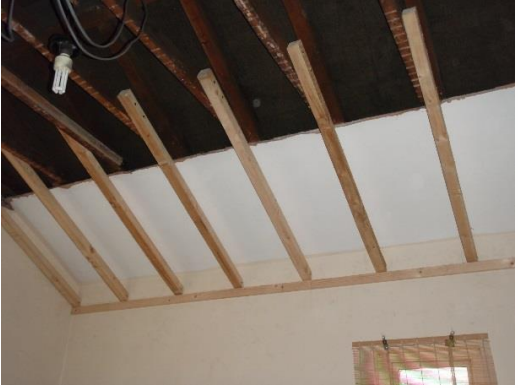
</div> </div>				Before	After	% reduction	Space heating (kWh/m <sup>2</sup> /yr)	248.8	78	69%	Primary energy (kWh/m <sup>2</sup> /yr)	467.3	179.8	62%	CO2 (kg/m <sup>2</sup> /yr)	107.7	42.9	60%
	Before	After	% reduction																
Space heating (kWh/m <sup>2</sup> /yr)	248.8	78	69%																
Primary energy (kWh/m <sup>2</sup> /yr)	467.3	179.8	62%																
CO2 (kg/m <sup>2</sup> /yr)	107.7	42.9	60%																
Fuel use before and after	No data before, as I had just moved in. Data after retrofit does not give accurate picture due to many periods when house has been unoccupied, especially during cold months.																		
What improvements done / strategies	<b>Improvement</b>		<b>U-values / information</b>																
	Insulation Bathroom ceiling		- Polyisocyanurate (Kingspan) 120mm thick friction-fitted in rafters, u-value 0.321 W/m <sup>2</sup> K

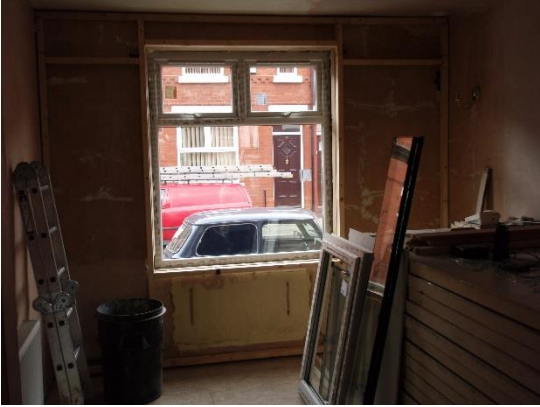
<p>Internal walls (external-facing – i.e. not party walls)</p>	<ul style="list-style-type: none"> <li>- Polyisocyanurate (Kingspan) 70mm thick friction-fitted in studwork, u-value 0.372 W/m<sup>2</sup>K</li> </ul>

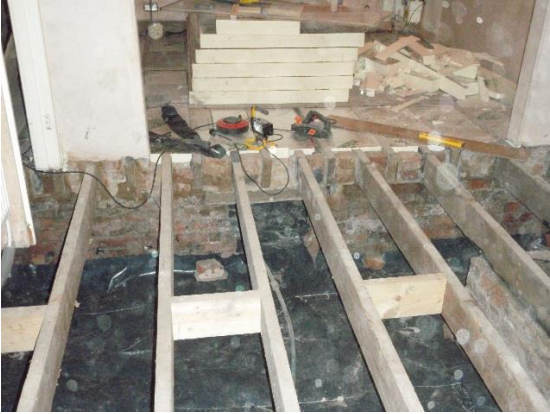
<p>Suspended timber floor</p>	<ul style="list-style-type: none"> <li>- Polyisocyanurate (Kingspan) 100mm thick friction-fitted between joists, u-value 0.321 W/m<sup>2</sup>K</li> </ul>

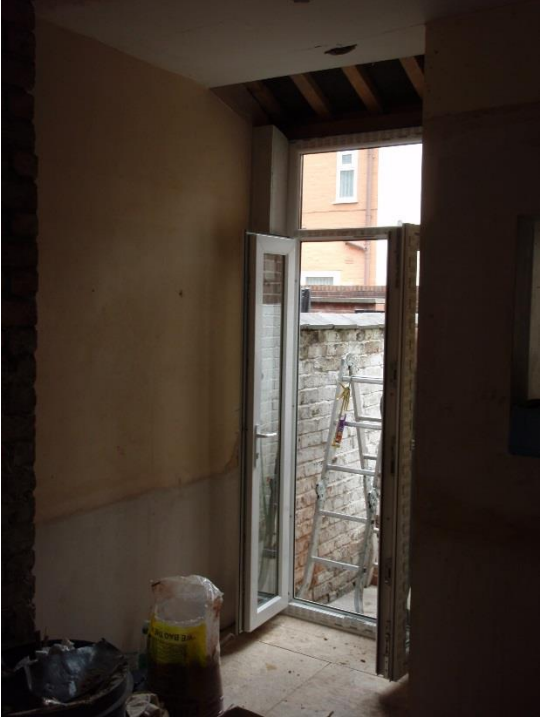
<p>Loft</p>	<ul style="list-style-type: none"> <li>- Mineral wool 270mm thick, u-value 0.149 W/m<sup>2</sup>K</li> </ul>
	<p>Bay window ceiling above French doors</p>	<ul style="list-style-type: none"> <li>- Polyisocyanurate (Kingspan) 100mm thick friction-fitted between rafters, u-value 0.332 W/m<sup>2</sup>K</li> </ul>

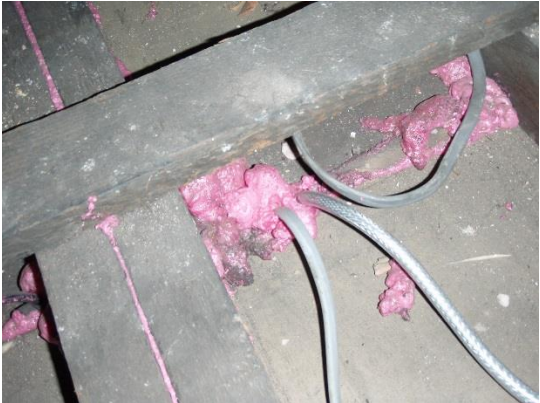
<b>Airtightness</b>		
	<p>Some vapour-impermeable sheeting, combined with use of expanding foam</p>	<ul style="list-style-type: none"> <li>- Vapour-impermeable polythene sheets used on insulated internal walls and bathroom ceiling, but these were not adequately taped or sealed to create a draught proof barrier</li> <li>- No membrane was used on ground floor – here I only relied on expanding foam</li> <li>- No membrane used on bedroom ceilings – here I used expanding foam to seal up between plasterboards and wire penetrations via the loft space</li> </ul>

<p>consisted largely of using expanding foam, which I now know is not an effective strategy. The polythene sheets were also not vapour permeable, and in any case were not correctly joined together or to walls/floors.</p> <ul style="list-style-type: none"> <li>- Proper MVHR design prior to procuring unit, to ensure that a lower flow rate can be achieved that would result in 0.3 air changes per hour in winter (to avoid dry air).</li> <li>- Wood fibre as insulation for internal wall insulation</li> <li>- Insulation for kitchen floor prior to concrete being laid</li> <li>- External wall faces treated with Keim Lotexan mineral paints (to reduce rain-driven moisture)</li> <li>- Better suspended floor insulation strategy – namely to put vapour-impermeable membrane beneath floor joists and sealed to crawl space walls, followed by vapour-impermeable insulation – e.g. polyisocyanurate. (This is following more than 12 months of research on joist moisture content that is still ongoing with the AECB and an academic researcher).</li> </ul>

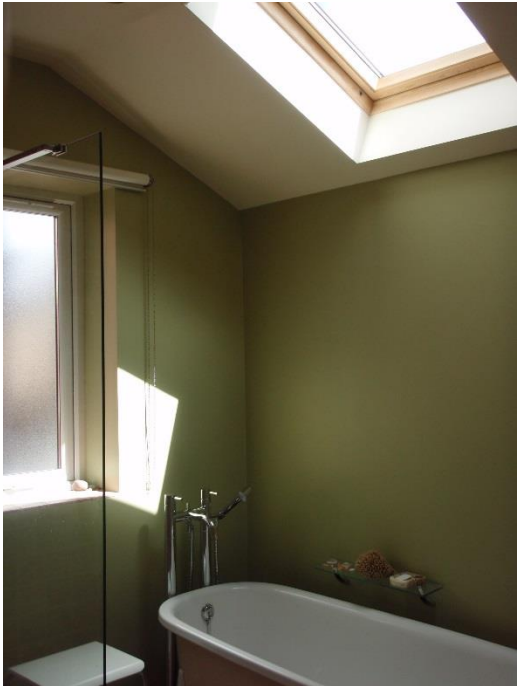
Doors & windows	
	New windows and doors	<ul style="list-style-type: none"> <li>- Rehau PVC double-glazed windows and French doors, with 28mm gap argon-filled glazing, u-value of whole window 2.2 W/m<sup>2</sup>K (glazing u-value 1.5 W/m<sup>2</sup>K)</li> <li>- One Velux wood-framed window in bathroom, u-value of whole window 1.98 W/m<sup>2</sup>K (glazing u-value 1.1 W/m<sup>2</sup>K)</li> </ul>

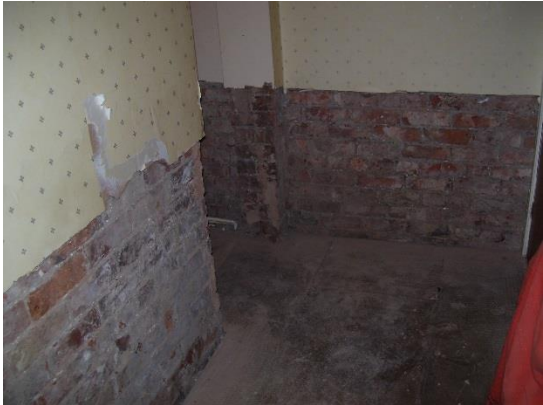
Damp		
Ground floor & walls	- I had an injected damp course done on the whole ground floor

<ul style="list-style-type: none"> <li>- Kitchen floor had to be drilled up and re-laid (rising damp due to inadequate DPM)</li> </ul>

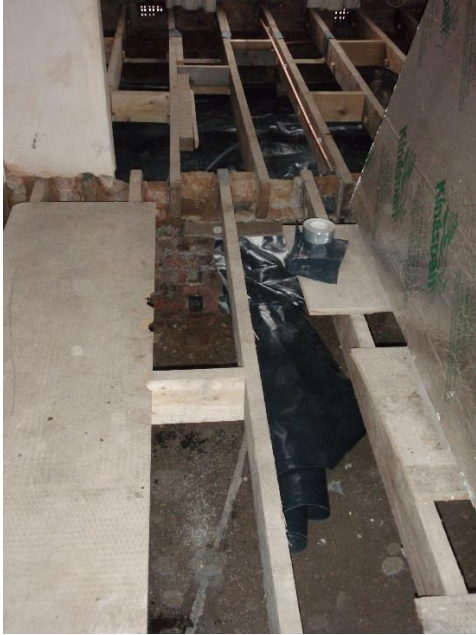
Crawl space	<ul style="list-style-type: none"> <li>- Put 4.5 tonnes of MOT (gravel mix) onto the muddy crawl space floor to soak up moisture and deal with mud and unevenness</li> <li>- After that I laid a thick polythene sheeting on top of this to reduce evaporation (cleared up the condensation on windows overnight)</li> </ul>

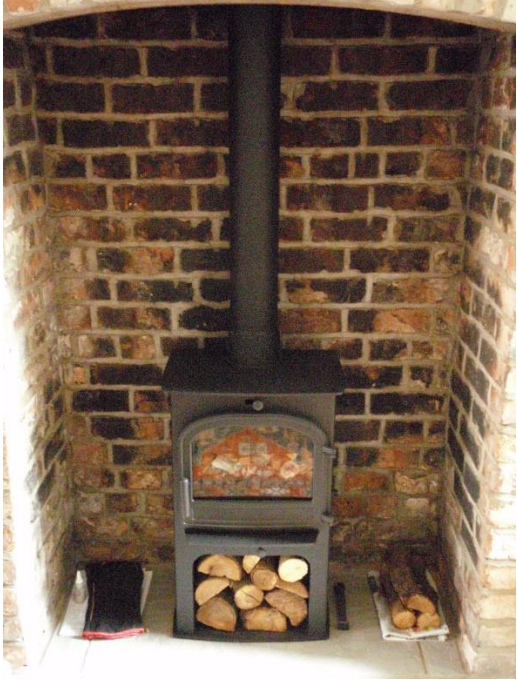
<b>Heating system</b>	
	Condensing boiler	<ul style="list-style-type: none"> <li>- Replaced old boiler with Remeha Avanta Plus condensing boiler</li> </ul>
Radiators	<ul style="list-style-type: none"> <li>- New radiators throughout, most with TRVs</li> </ul>	
Wood-burning stove	<ul style="list-style-type: none"> <li>- Løvenholm 5kW HETAS-approved smokeless zone stove put into larger chimney breast on ground floor</li> <li>- Appropriate chimney cowl added to stack</li> </ul>
